# STARTER - REDUCTION GEAR

1988 Toyota Celica

1988 Starters  
MITSUBA & NIPPONDENSO REDUCTION GEAR

Toyota Camry, Celica, Corolla, Cressida,  
Land Cruiser, Pickup, MR2, Supra, Van, 4Runner

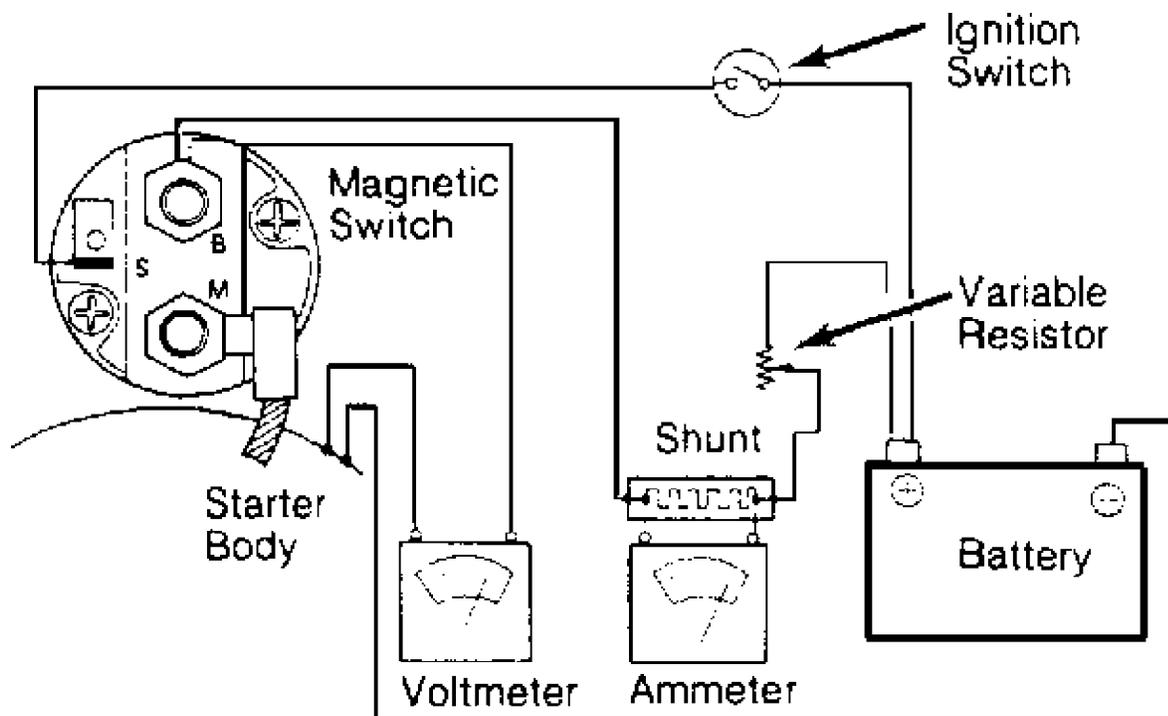
29427

Fig. 1: Ammeter & Voltmeter Hook-Up for No Load Test  
Courtesy of Subaru of America, Inc.

1) Remove starter. Connect ammeter in series with starter motor and 12-volt battery. See Fig. 1. Connect voltmeter in parallel with battery and observe readings.

2) Starter should spin smoothly at 3000 RPM or more with current draw less than 90 amps at 11.5 volts.

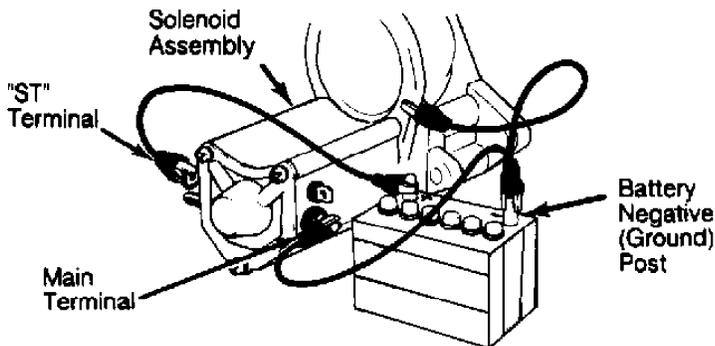
29429

Fig. 2: Solenoid Pull-In Coil Test  
Courtesy of Toyota Motor Sales, USA, Inc.

Connect 2 battery negative leads to main terminal ("C") and ground. Connect a 12-volt battery positive lead to solenoid "ST" terminal (terminal "50"). See Fig. 2. Plunger should extend firmly. If not, replace solenoid.

After pull-in testing, disconnect battery negative lead from

main terminal ("C"). Plunger should remain extended. If not, replace solenoid. See Fig. 2.

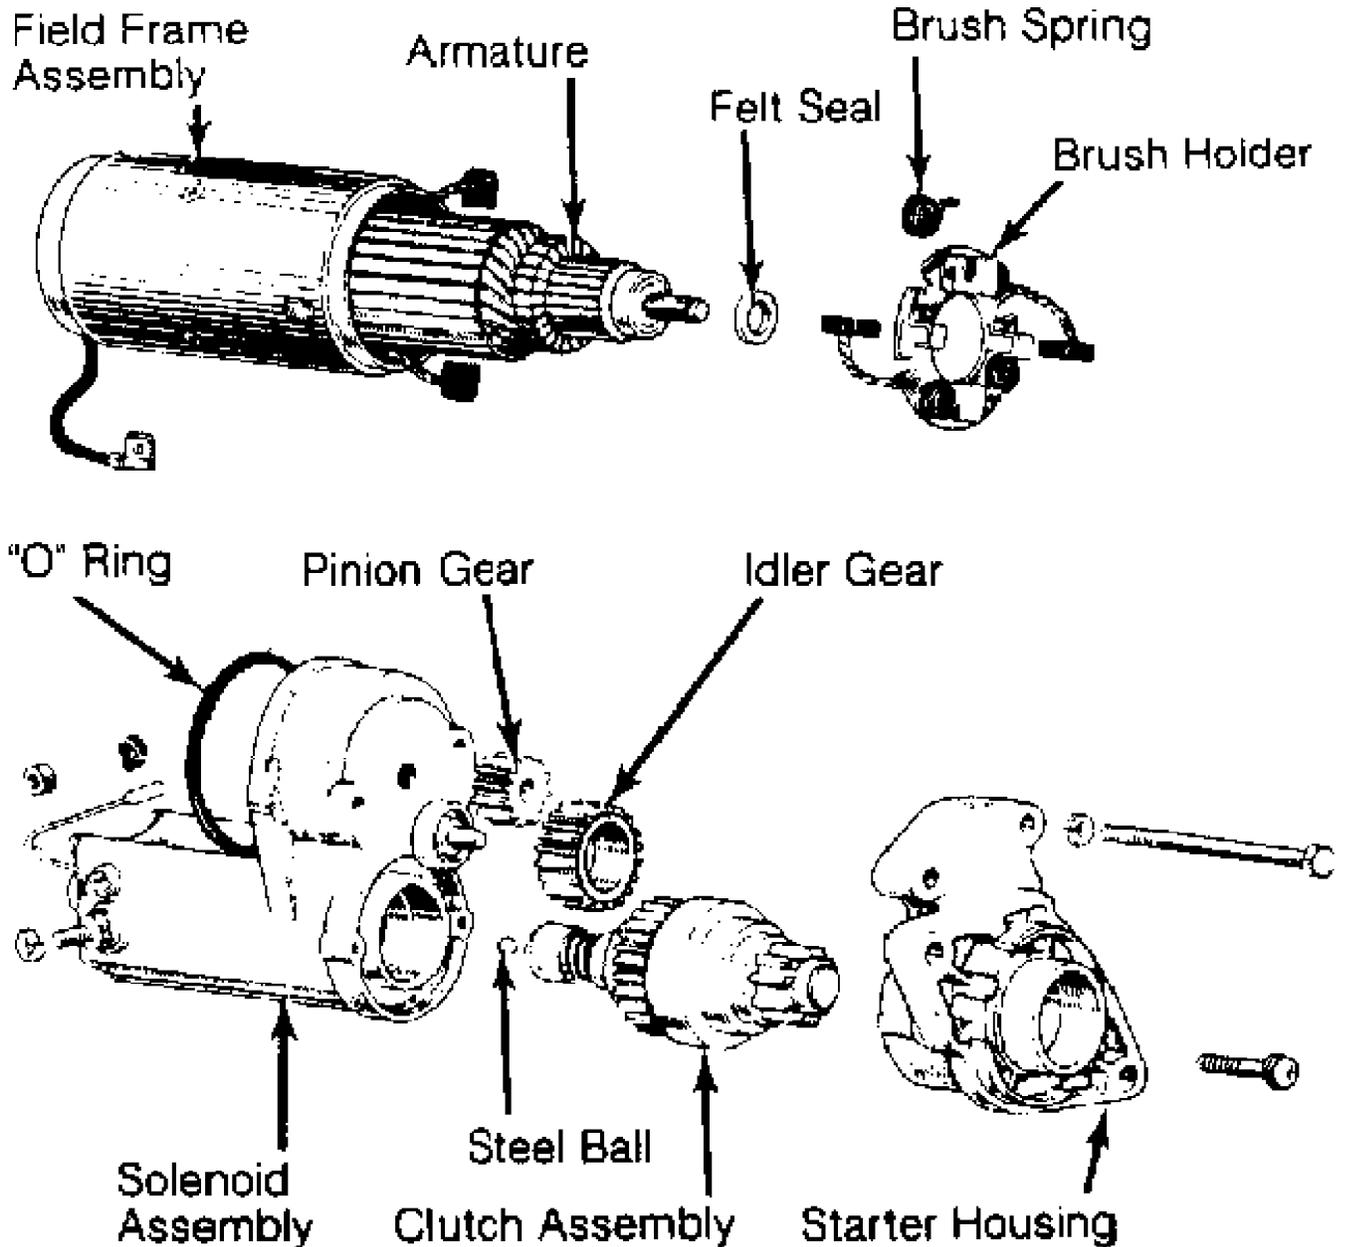
26594

Fig. 3: View of Nippondenso Reduction Gear Starter  
Courtesy of Toyota Motor Sales, USA, Inc.

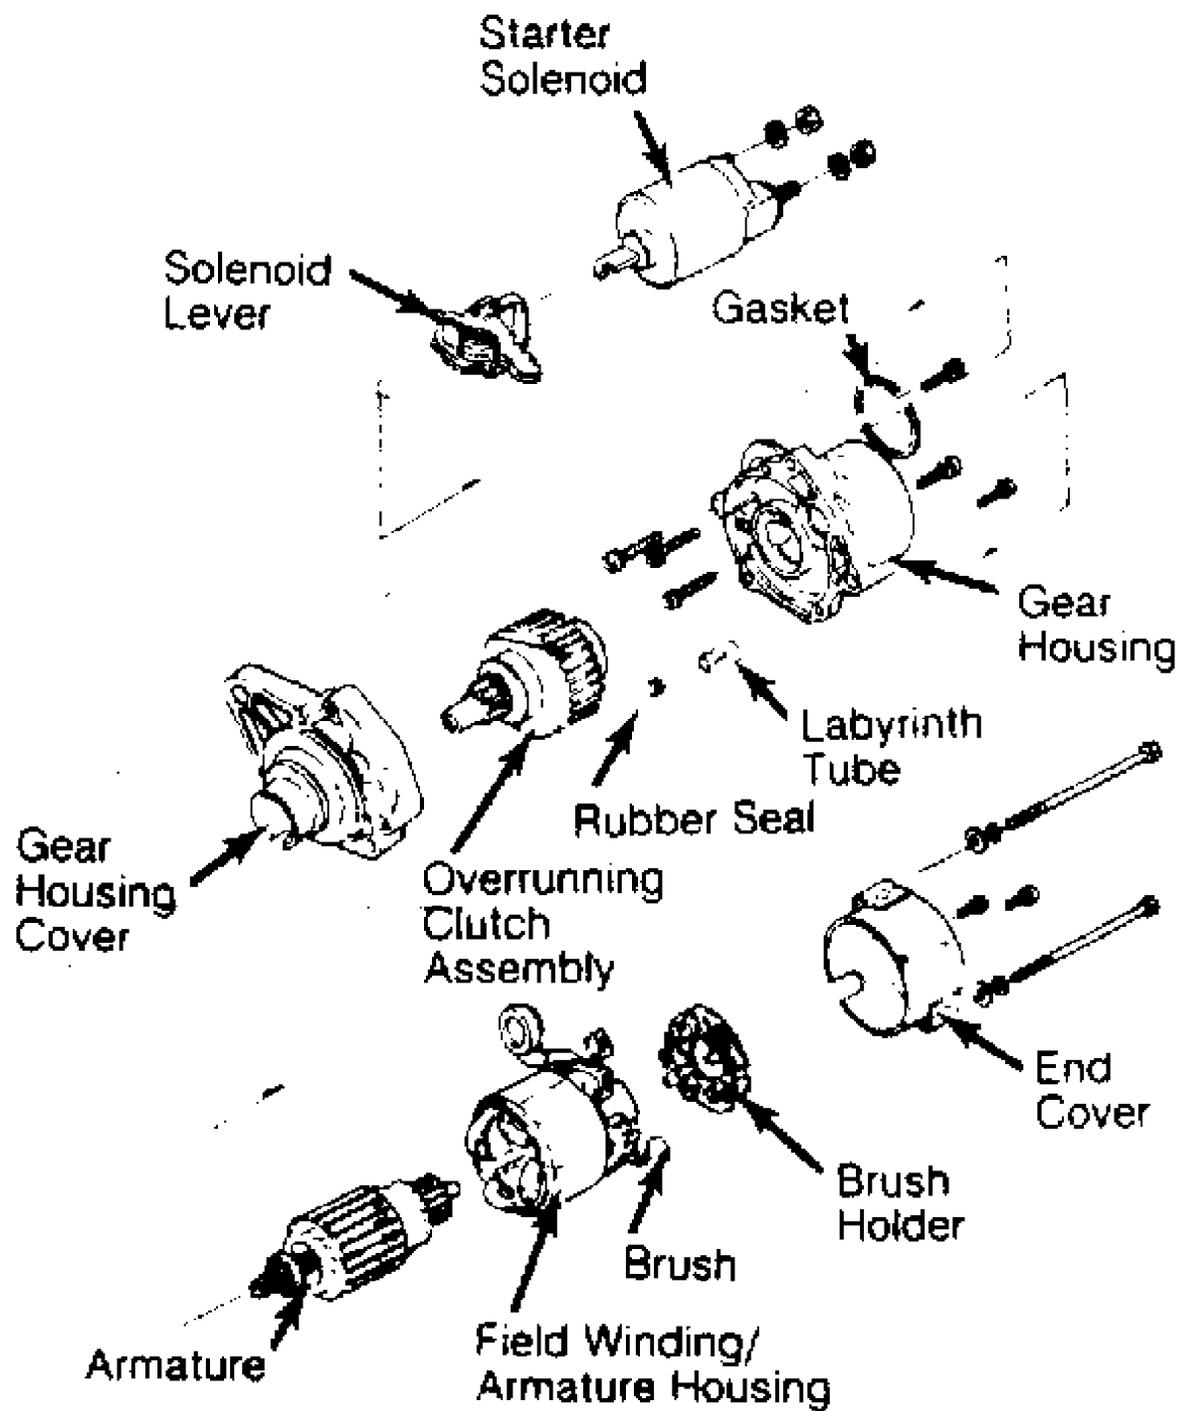
Fig. 4: View of Mitsuba Reduction Gear Starter  
 Courtesy of American Honda Motor Co., Inc.
